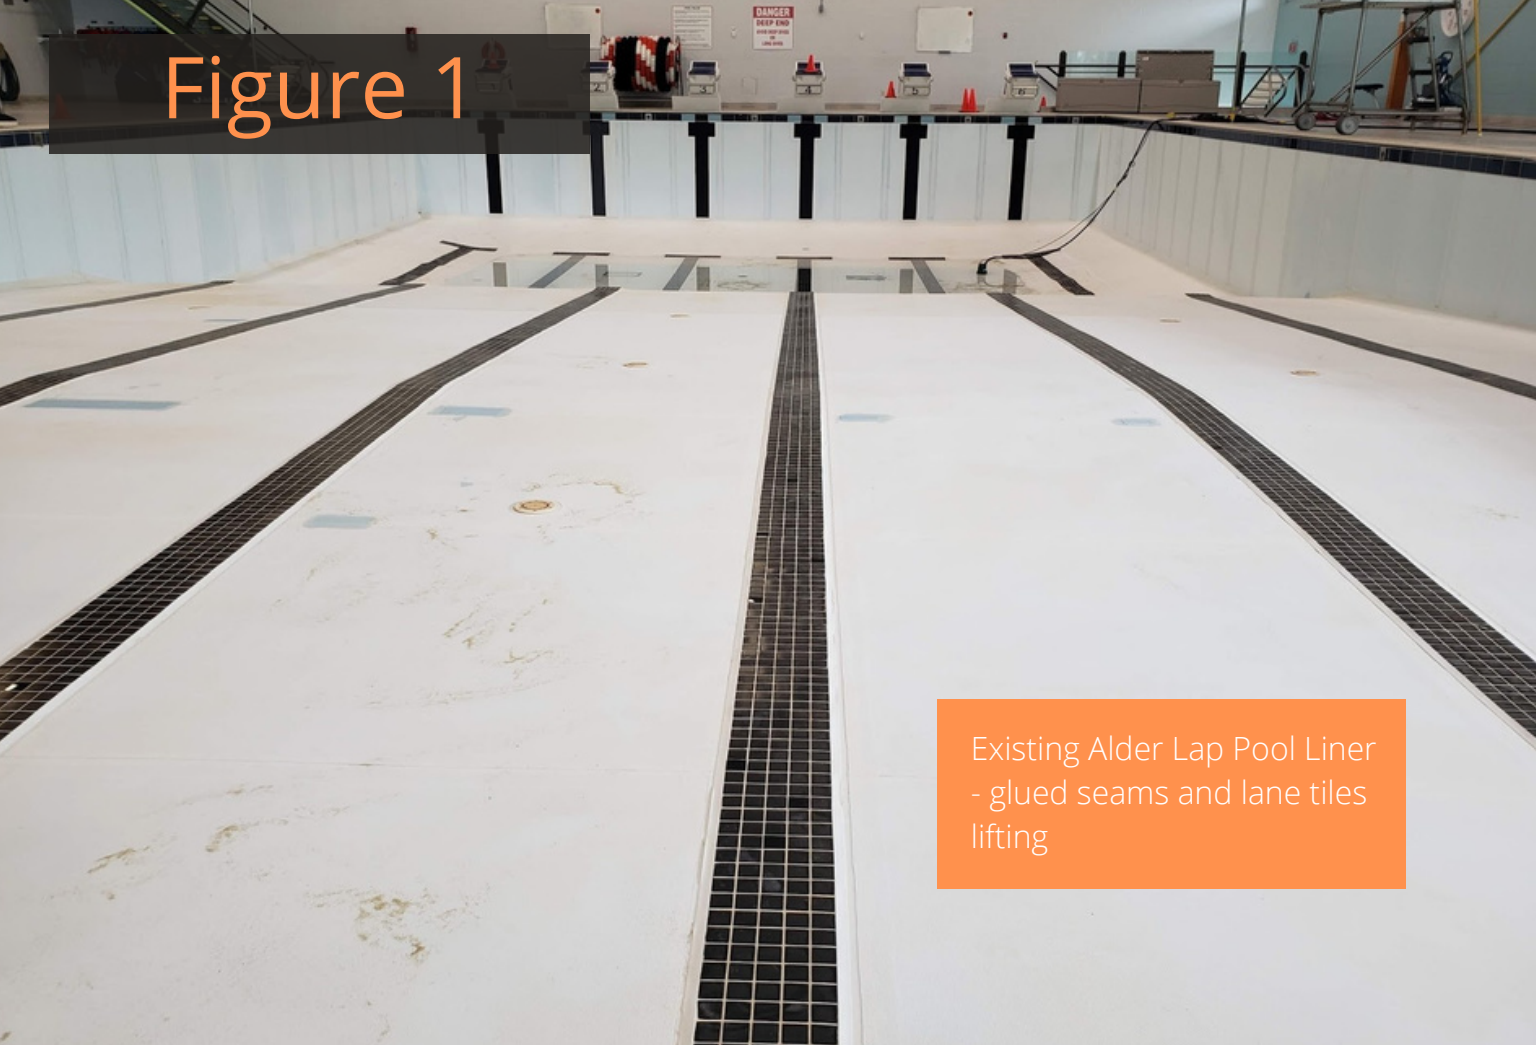
Figure 1

Existing Alder Lap Pool Liner
- glued seams and lane tiles
lifting

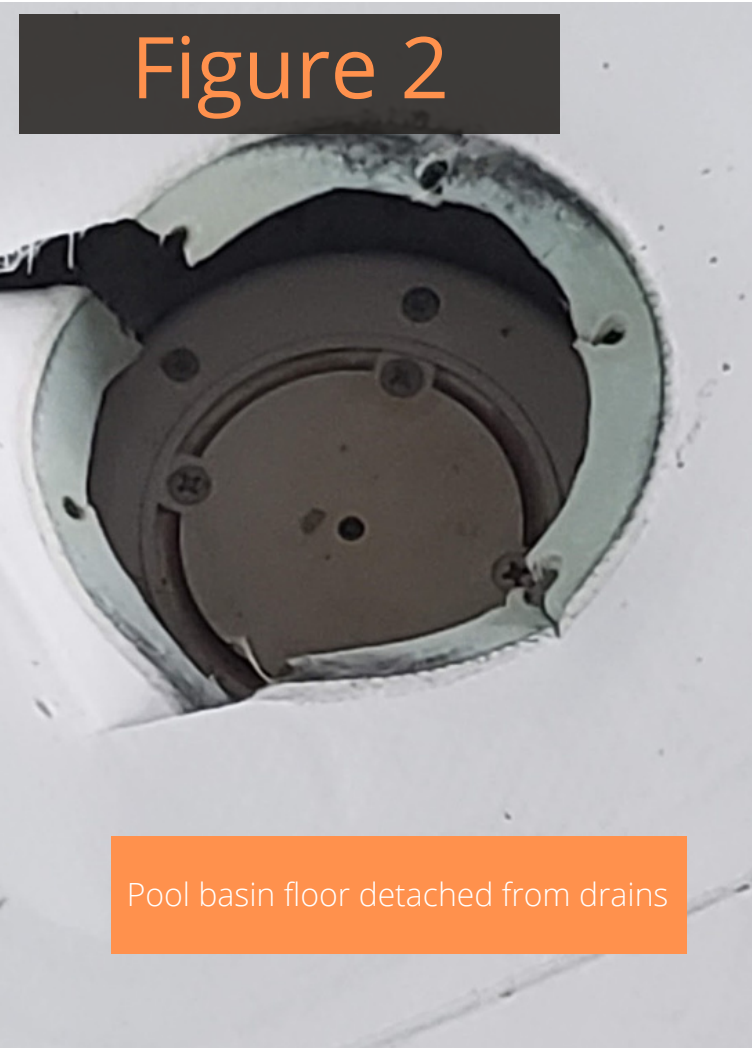
Figure 2

Pool basin floor detached from drains

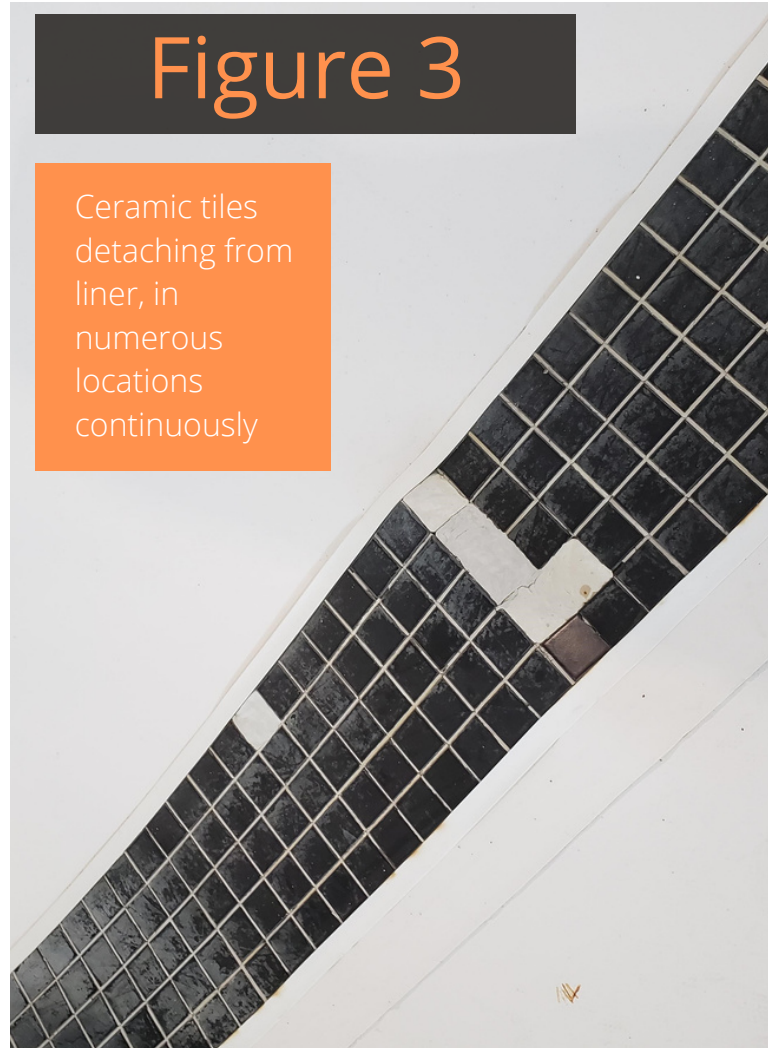
Figure 3

Ceramic tiles
detaching from
liner, in
numerous
locations
continuously
