**Subject:** Alder Recreation Centre Pool – Structural Deficiencies

**Report #:** CMS-2021-020

**Meeting Date:** 2021-10-18

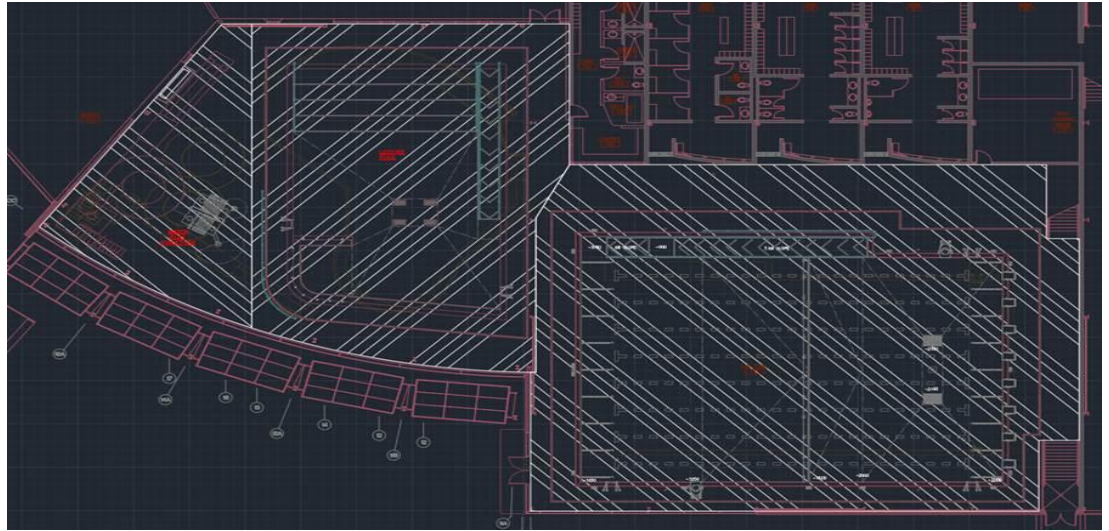
Removal of the pool deck was required as part of the base contract, in order to excavate around the pool(s) and remove the failing Myrtha pool systems. In the process of excavation, it revealed significant collapse of base soils in around the pool which was causing tile delamination in and around the pool(s). The pool deck itself, although substantial in size, did not have any structural steel or mesh within it to provide additional strength and resist movement. Due to the soil collapse below, the pool deck was acting as a suspended slab with no structural elements within it. (see photo)

The liquefaction (saturation) of the subsoils is evident due to the collapse, or voids created directly below the pool deck. As the water moves through the soil the water would carry with it small soil particles and sand, known as finds. This is a direct result of water loss from the Myrtha pool system leaking from the pool(s) and / or pool piping and migrating through the sub-soils. Further indication of water damage was noted on the back of the pool walls with a relative straight line of corrosion on the brackets supporting the Myrtha pool walls. (see photo at lap pool excavation)

**Item 1.** Remove sub-soils below level of existing clear stone to expose virgin soil and prepare for new pool(s) concrete slabs. Provide engineered fill to bring excavation of removed 'spongy' material to an acceptable depth, based on recommendations from Terrapex-Geotechnical Engineers, including delivery, placement, compaction, etc.
