TOWN OF ORANGEVILLE

REPLACEMENT OF SIDEWALKS AND BOULEVARDS CENTRAL BROADWAY (JOHN STREET TO THIRD STREET)

April, 2021

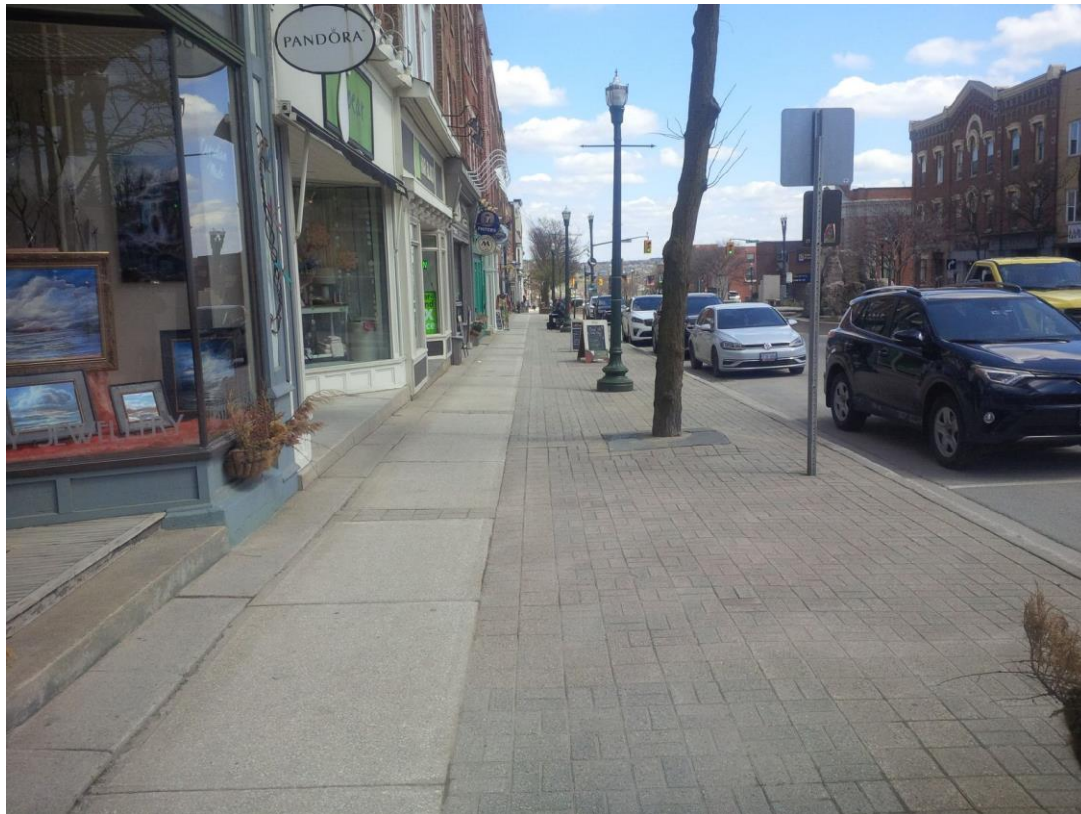
The existing surface consists predominantly of precast concrete paving stone, with a cast-in-place concrete sidewalk adjacent to the buildings. The concrete sidewalk has a 200mm wide paving stone strip every three panels, that was provided for aesthetic reasons. The width of the sidewalk varies from approximately 1.2m to 1.5m due to the inconsistent building setback from the property line. The 3.25 metre width from the sidewalk to the back of curb consists of paving stone, the majority of which are 100x200mm in size, with some 200x200mm pavers for contrast. Refer to photo 1 in Appendix A.

Photo 1 – Existing sidewalk configuration with 1.5m concrete sidewalk, banding, and paving stone blvd

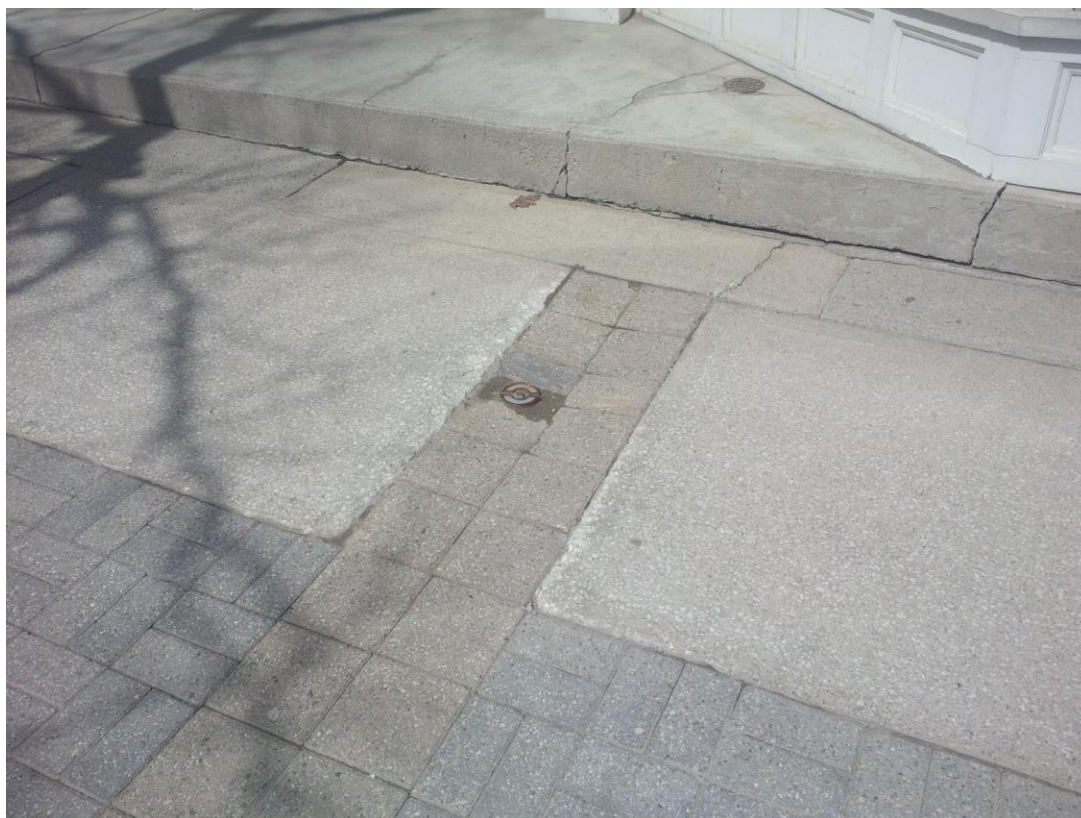
- Differential movement between concrete and pavers, in particular the narrow paving stone course between the concrete slabs, creating trip hazards (photo 2);
- Movement and shifting of the paving stones (photo 6);
- Heaving of tree grates and paving stones around the boulevard trees (photo 3);
- Vertical movement of curb stops and water valves where they are located in the paving stone (photo 2);
- Sidewalk ramps at curbs do not meet current AODA standards;
- Electrical junction boxes have shifted or broken and create trip hazards (photo 5);
- Fountains and watering hose bibs are no longer functional;
- Parking meter posts that are no longer functional due to meters no longer being used (photo 7);
- Additional issues regarding streetscape furniture and other amenities identified by the BIA.

Photo 2 – Settlement in paving stone band and curb stop

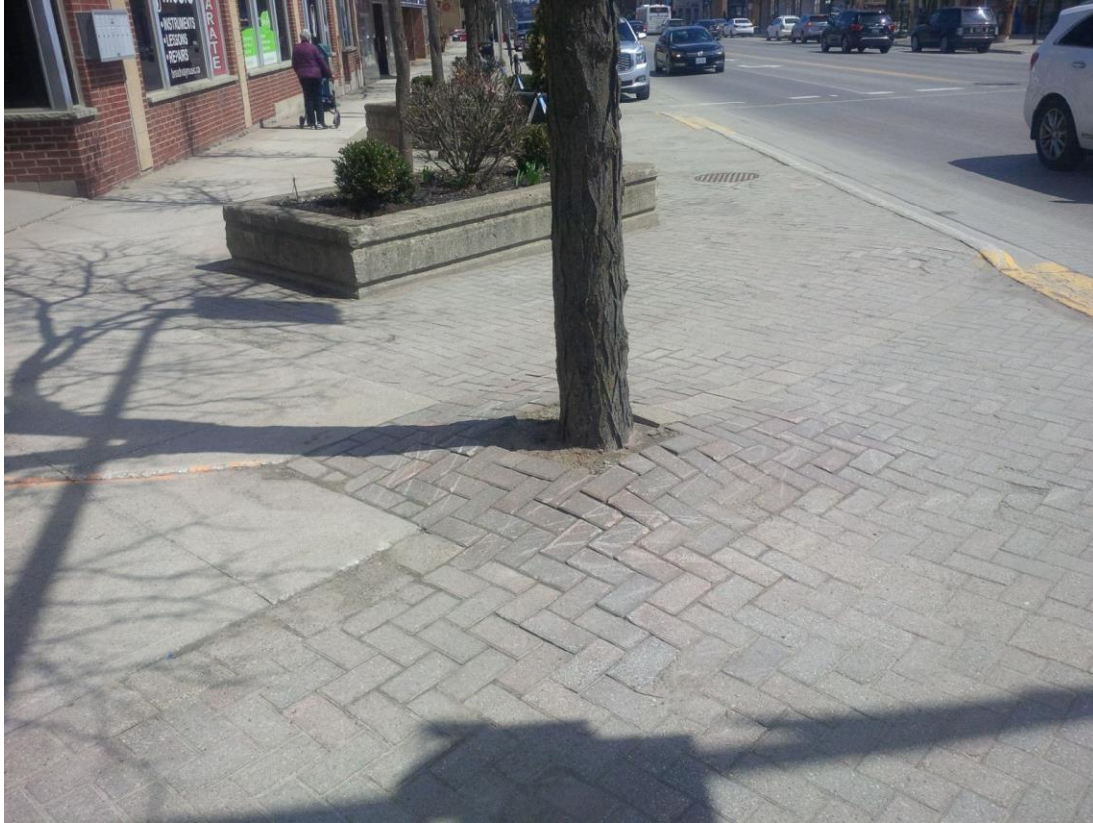
Photo 3 – Paving Stone heaving around tree

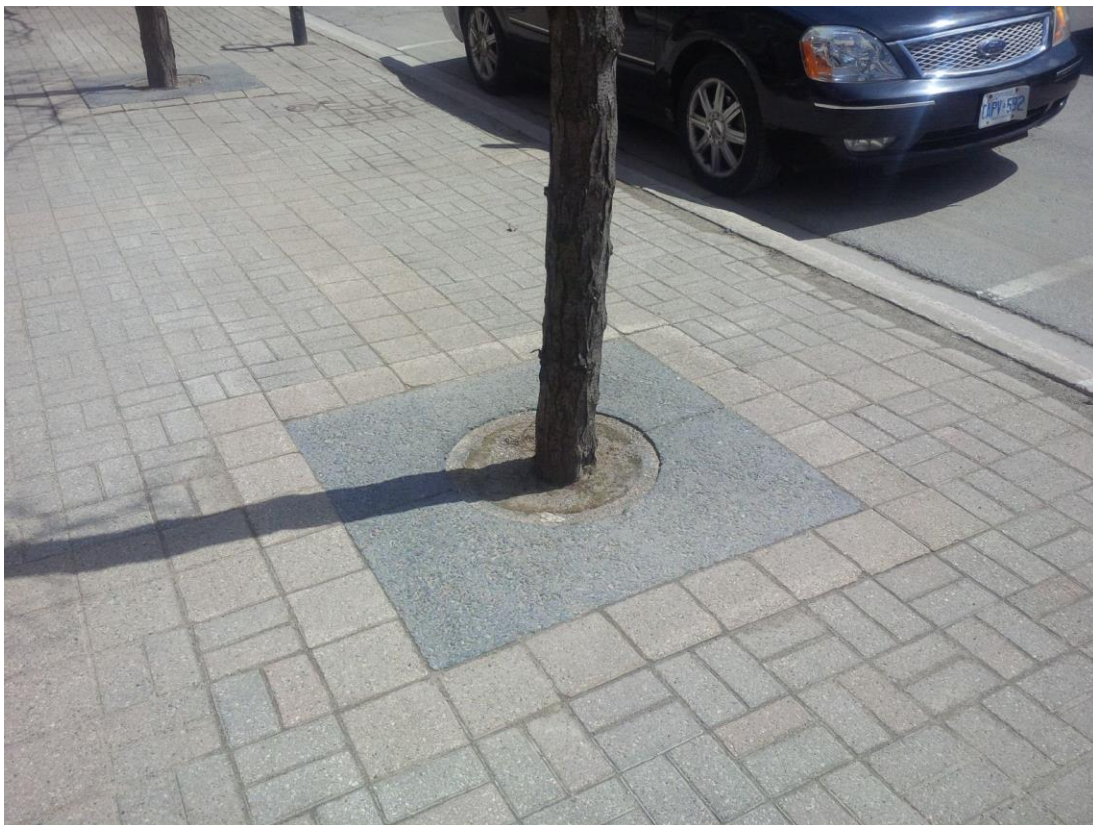
Photo 4 - Tree with original tree grate and no heaving

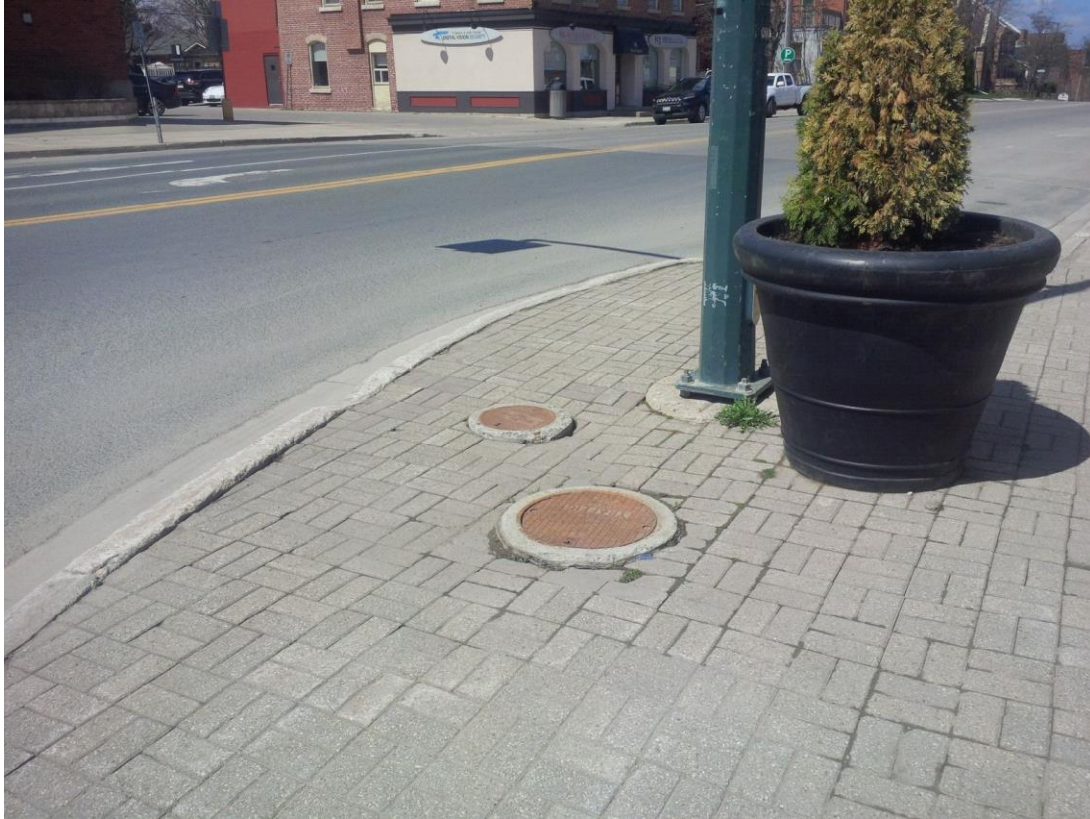
Photo 5 – Settlement around junction boxes

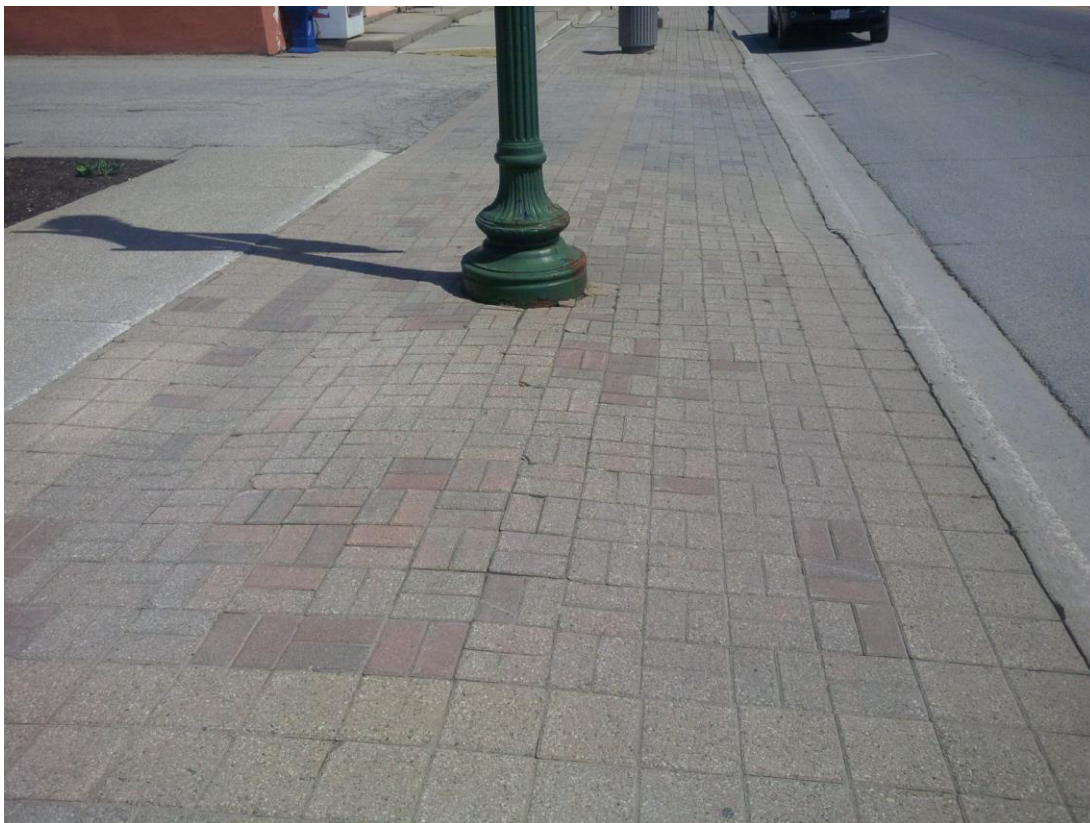
Photo 6 – Uneven and broken paving stones

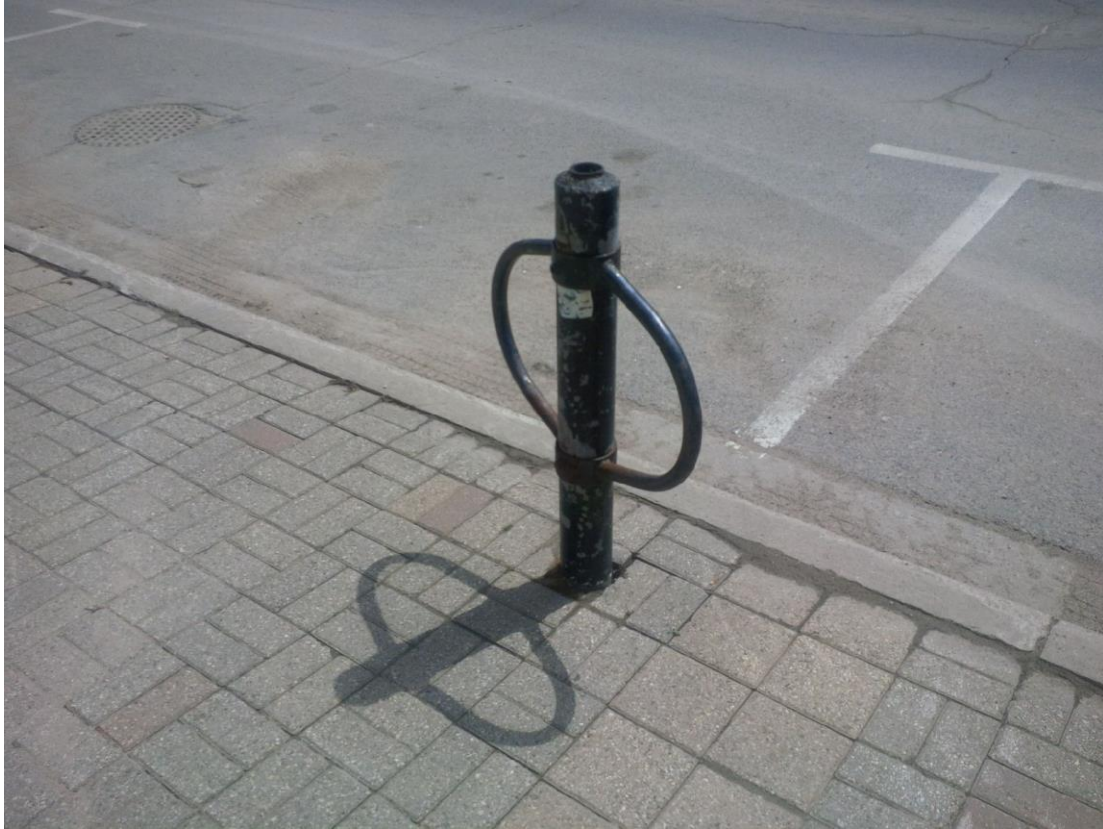
Bicycle Racks A number of the parking meter posts have been converted to bike racks, but are unsightly and located too close to the curb for practicality. Consideration should be given to new bike rack design and placement. Staff will collaborate with others to ensure a single efficient design is established and placed in those areas where

Photo 7 – Parking Metre Posts converted to Bike Racks

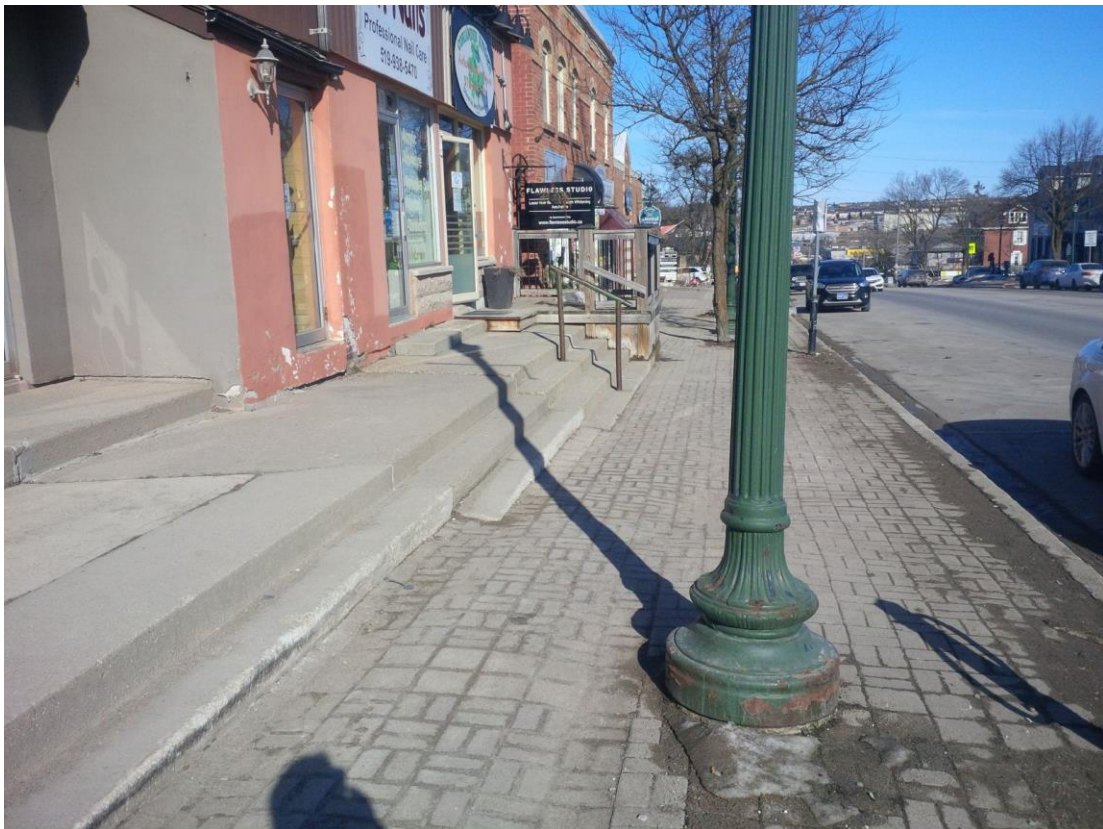
There are existing steps in front of No. 85 Broadway (which includes four businesses) that are in the municipal right-of-way. These steps are not AODA compliant, and it is recommended that they be replaced with a common ramp with the required railings.

Photo 8 – Existing steps at 85 Broadway
