Final Study Report

Downtown Orangeville Transit Transfer Station Safety Study

November 5, 2020

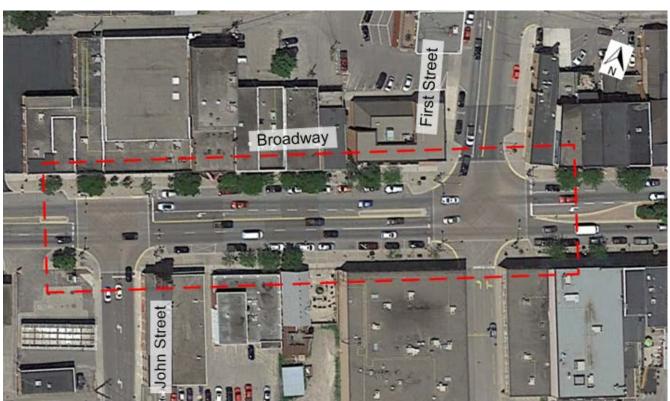
Exhibit 1-1: Study Area

The site of the proposed transit transfer location is on Broadway, between First Street and John Street (Exhibit 2-1). This location is a short midblock segment approximately 90metres long, and is bookended by two signalized intersections. Within the study area, Broadway has a four-lane configuration consisting of one a dedicated left-turn lane and a through lane in each direction. There is also a curbside parking lay-by on each side of the street. This portion of Broadway is

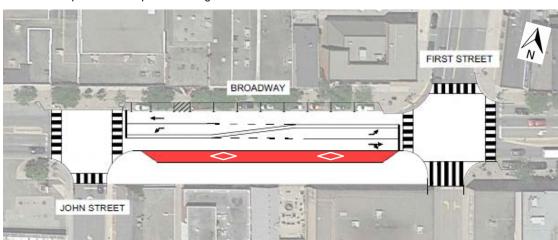
Exhibit 8-1: Option 1 Conceptual Drawing

This option involves the removal of one traffic lane through the implementation of back-to-back left-turn lanes for the eastbound left-turn at First Street and the westbound left-turn at John Street. The single travel lanes in the eastbound and westbound direction would be maintained. The space gained from the removal of a traffic lane have been added to the south sidewalk on Broadway to provide additional space to accommodate transit amenities, passenger queueing areas, while still providing space on the sidewalk for pedestrians and mobility devices. This design results in the eastbound left-turn lane at First Street being shifted to the north, which removes the existing negative offset with the westbound through lane, improving visibility for left-turning drivers. The removal of a traffic lane would also result in a reduced road cross section, shortening the crossing distance for pedestrians in the west crosswalk. The addition of ladder markings in crosswalks will improve visibility of crossing pedestrians, and may attract more pedestrians to cross at the intersection.

A challenge associated with this design is that there is a significant lane shift in the eastbound through lane at First Street. This may result in drivers mistakenly driving onto the median on the east leg of First Street. Another challenge related to this design is that the left-turn lanes are shortened, which may result in queues blocking the through lane. However, due to the additional queues, drivers may find alternate routes to avoid turning left at First Street, resulting in Broadway serving downtown visitors instead of pass-through trips.

A conceptual drawing of this configuration is shown in Exhibit 8-1.

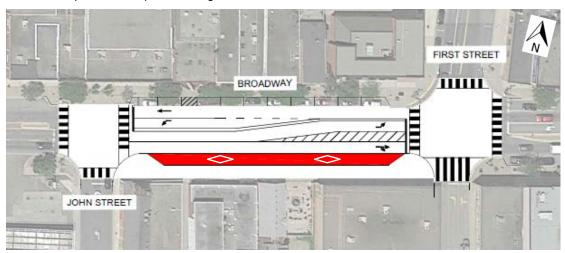
Exhibit 8-2: Option 2 Conceptual Drawing

This option involves the realignment of the eastbound left-turn lane at First Street through the implementation of a slot left-turn lane. There would be a painted or physical median replacing the existing left-turn lane, pushing the left-turn lane further north. This allows for improved visibility of opposing through vehicles for eastbound and westbound left-turning drivers at First Street. Compared to existing conditions, this potential configuration would require the removal of the median on the west leg of the intersection, but the curbs and roadway width would remain the same. Eastbound left-turn storage would also be largely unaffected. Similar to Configuration 1, the addition of ladder markings in crosswalks will help to increase pedestrian visibility in crosswalks.

A challenge associated with this configuration is that the westbound left-turn lane length would be reduced to accommodate the realigned eastbound left-turn lane. This may result in the queues associated with the westbound left-turn movement at John Street obstructing the westbound through lane.

A conceptual drawing of this configuration is shown in Exhibit 8-2.

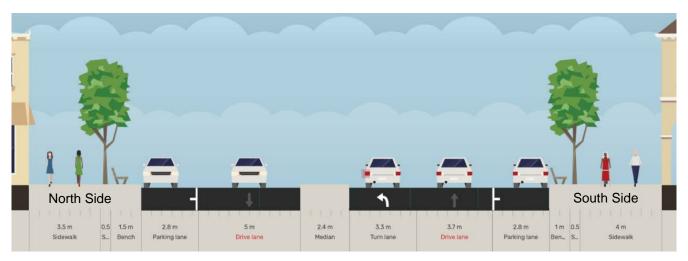
Exhibit 8-3: Existing Cross-section at First Street, Looking East

The existing and potential cross-sections at First Street are shown in Exhibit 8-3, Exhibit 8-4, and Exhibit 8-5. Note that the measurements shown in the cross-sections are approximate, and more detailed surveys will be conducted in the next phases of design.

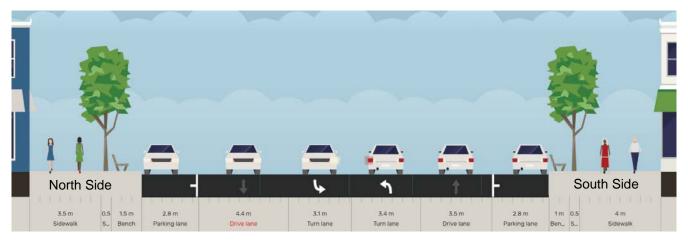
Exhibit 8-6: Existing Cross-section at John Street, Looking East

The existing and proposed cross-section for John Street, looking east, are shown in Exhibit 8-6, Exhibit 8-7, and Exhibit 8-8.
